**APEX
HOME
Inspections**

INSPECTION REPORT

INSPECTED BY
Jaime Kiefer
Apex Home
Inspections

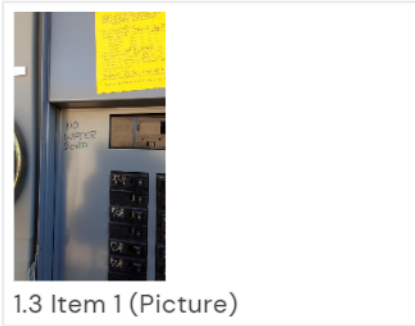
Based on the date of construction and markings in the electric panel indicating no water bond is present, it is assumed the home has polyethylene plumbing. I could not find a location to verify this visually.

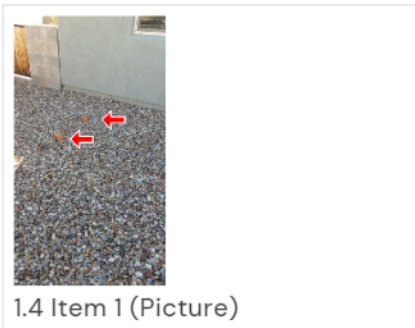
The waste drain clean-out(s) at the front of the home.

I recommend having the sewer line on the residence video inspected. Sewer lines can deteriorate, become clogged or closed off by root systems and homeowner debris and are susceptible to breakage, collapse or settling and are expensive to repair. The amount of water used in our testing does not replicate normal usage where bathing, laundry or flushing of solids are taking place or give an accurate portrayal of flow and subterranean system performance during heavy use. Video inspections help determine that latent defects do not exist.

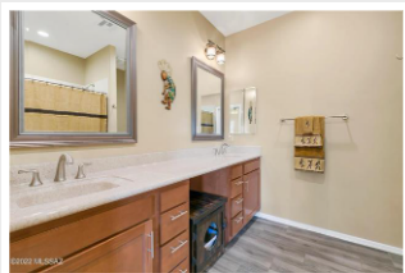
8.0.A Item 1 (Picture)

View of Bathroom

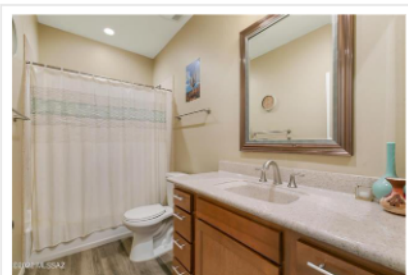
8.0.B Item 1 (Picture)

View of Bathroom

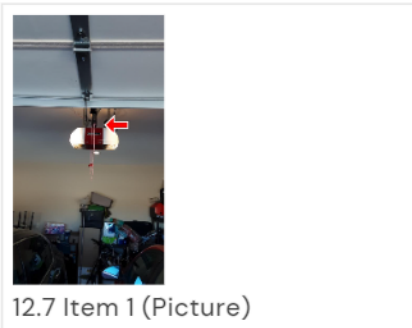
The garage door tension system is not adjusted correctly. One of the tests performed on the garage door is to activate the emergency release when the door is in the open position to determine if the door tensioning system will hold the door open. This garage door failed to remain in the open & neutral position. Cause for failure can be as simple as tension adjustment or severe as failed springs or torsion assemblies. This is a safety hazard and should be corrected by a qualified person.

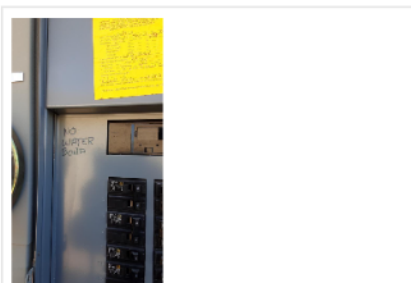
1.3 Item 1 (Picture)

Based on the date of construction and markings in the electric panel indicating no water bond is present, it is assumed the home has polyethylene plumbing. I could not find a location to verify this visually.
